Damage to Grier St. POC [Br. #53-1158] Post-Earthquake Investigation Team Report

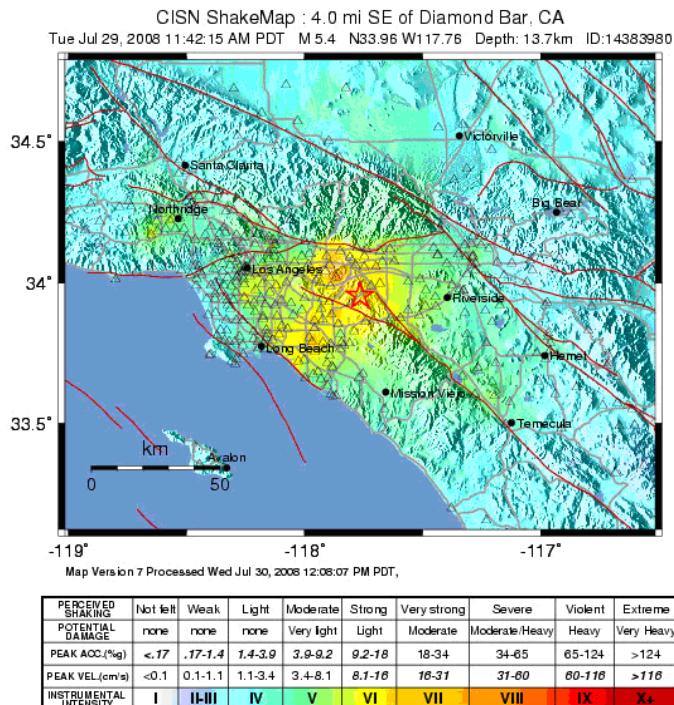
Figure 1 Shake Map.

The event was felt across southern California, with strong shaking reported to the north in the Chino Basin and to the west in the Los Angles basin (Figure 1). California State University, Fullerton, located about 10 miles west suffered some damage in its older buildings. A minor landslide near Route 91 in the Anaheim Hills 7 miles to the south caused some traffic congestion, but no injuries or structural damage were reported.

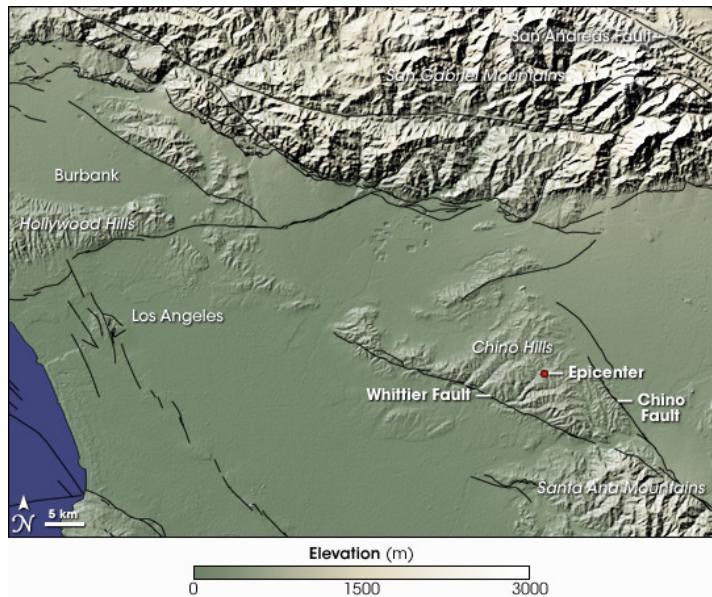
Figure 2 Location of the epicenter of the July 29, 2008 M5.4 Chino Hills earthquake.

According to Sue Hough of the USGS, the earthquake occurred in a complicated tectonic region — the wedge sandwiched between the Whittier and Chino Hills faults (Figure 2) that probably has a lot of small faults with different orientations. The current theory is that the wedge described above conceals a structure known as the Yorba Linda trend with no surface expression but identified as a linear trend of seismicity by Caltech seismologist Egill Hauksson in 1990. The moment tensor for this earthquake showed a mixture of thrust and left-lateral strike-slip faulting on a plane striking 43 deg east of north, with a dip of 58 deg southerly. The preliminary locations of the aftershocks suggest that this is the fault plane. Updates to this information may be found at:

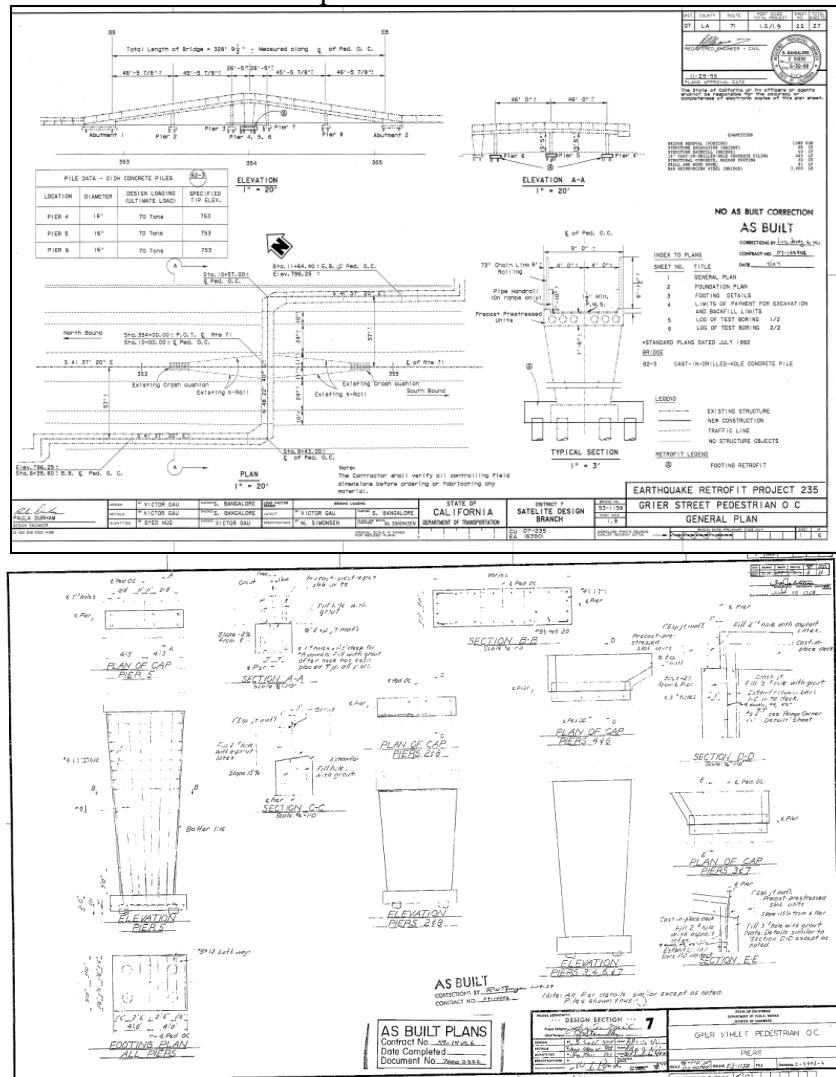
Attachment 1: As Built Plans

See the general plan for the bridge geometry and dimensions. See the as-built pier detail sheet for more information on pier connection details.
